II. Work in Progress

Phoenix Project

WEDGE 1

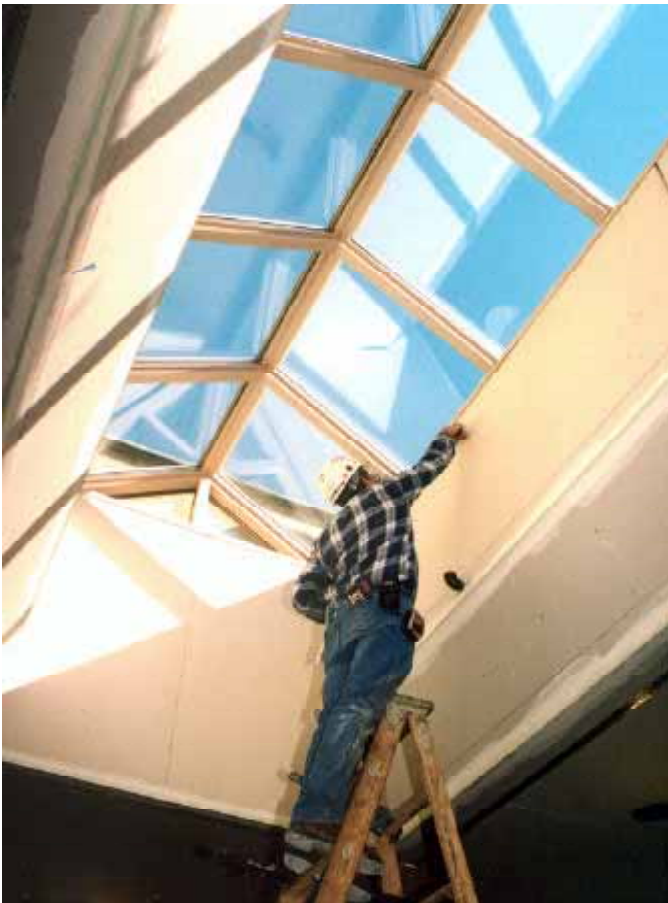
The skylights in the new Wedge 1 cafeteria, between the B and C-rings on the second floor, survived the blast from the terrorist attack without a crack. However, the cafeteria itself (pictured next page) suffered severe water and smoke damage.

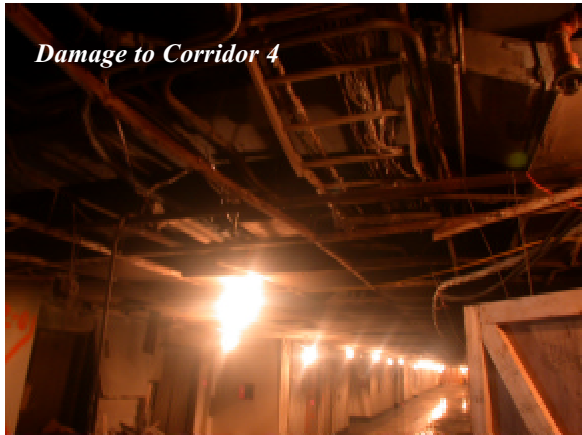
Damage to Corridor 4

Smoke and water damage in the cafeteria. The remains of the double glass doors from Corridor 4 can be seen on the floor.

Many areas not in the direct path of Flight 77 suffered water damage from the newly installed sprinkler system. Debris and smoke damage from the ensuing explosion affected other areas like the new cafeteria.

To the right, the results of the many hours of work crews spent on cleanup and reconstruction of these areas.
